EAST STROUDSBURG DAM

PHASE I INSPECTION REPORT NATIONAL DAM INSPECTION PROGRAM

NDS I.D. NO. PA 00637
DER I.D. NO. 45-155

East Stroudsburg Dam. NDS ID PA-00637.
DER ID-45-155. Delaware River Basin.
Sambo Creek, Monroe County, Pennsylvania.
Phase I Inspection Report.

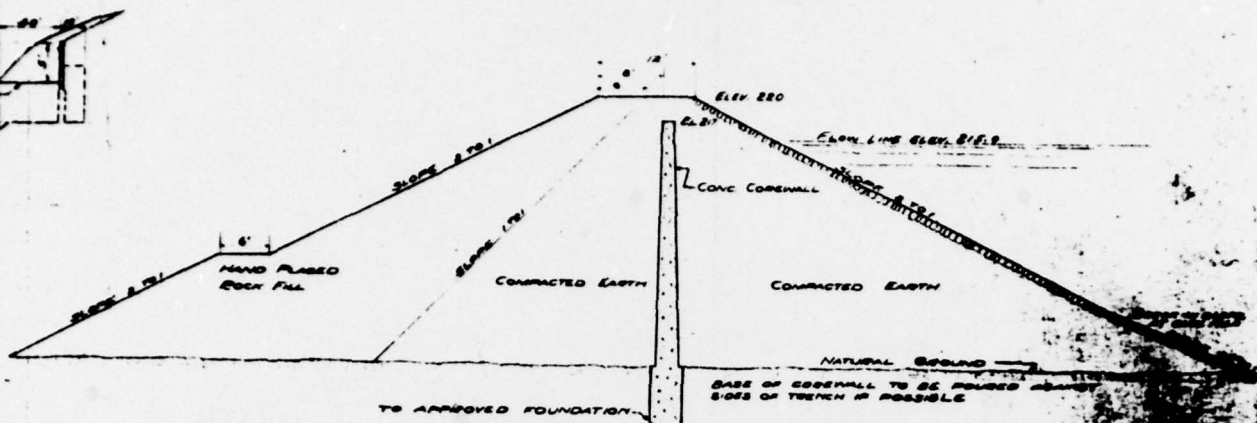
PLATE 3

Dewatering problems were encountered during the core wall foundation excavation. Water entered the excavation primarily from the downstream side through several gravel

zones. Additional excavations in the area revealed a large gravel layer, shown on the typical section enclosed herein as Plate 3. This gravelly and boulder ridden zone was a constant source of seepage and foundation construction problems. Seepage was controlled by a series of sumps and terra cotta drainage pipes. As the fill work proceeded, these terra cotta pipes were filled with concrete and sealed.

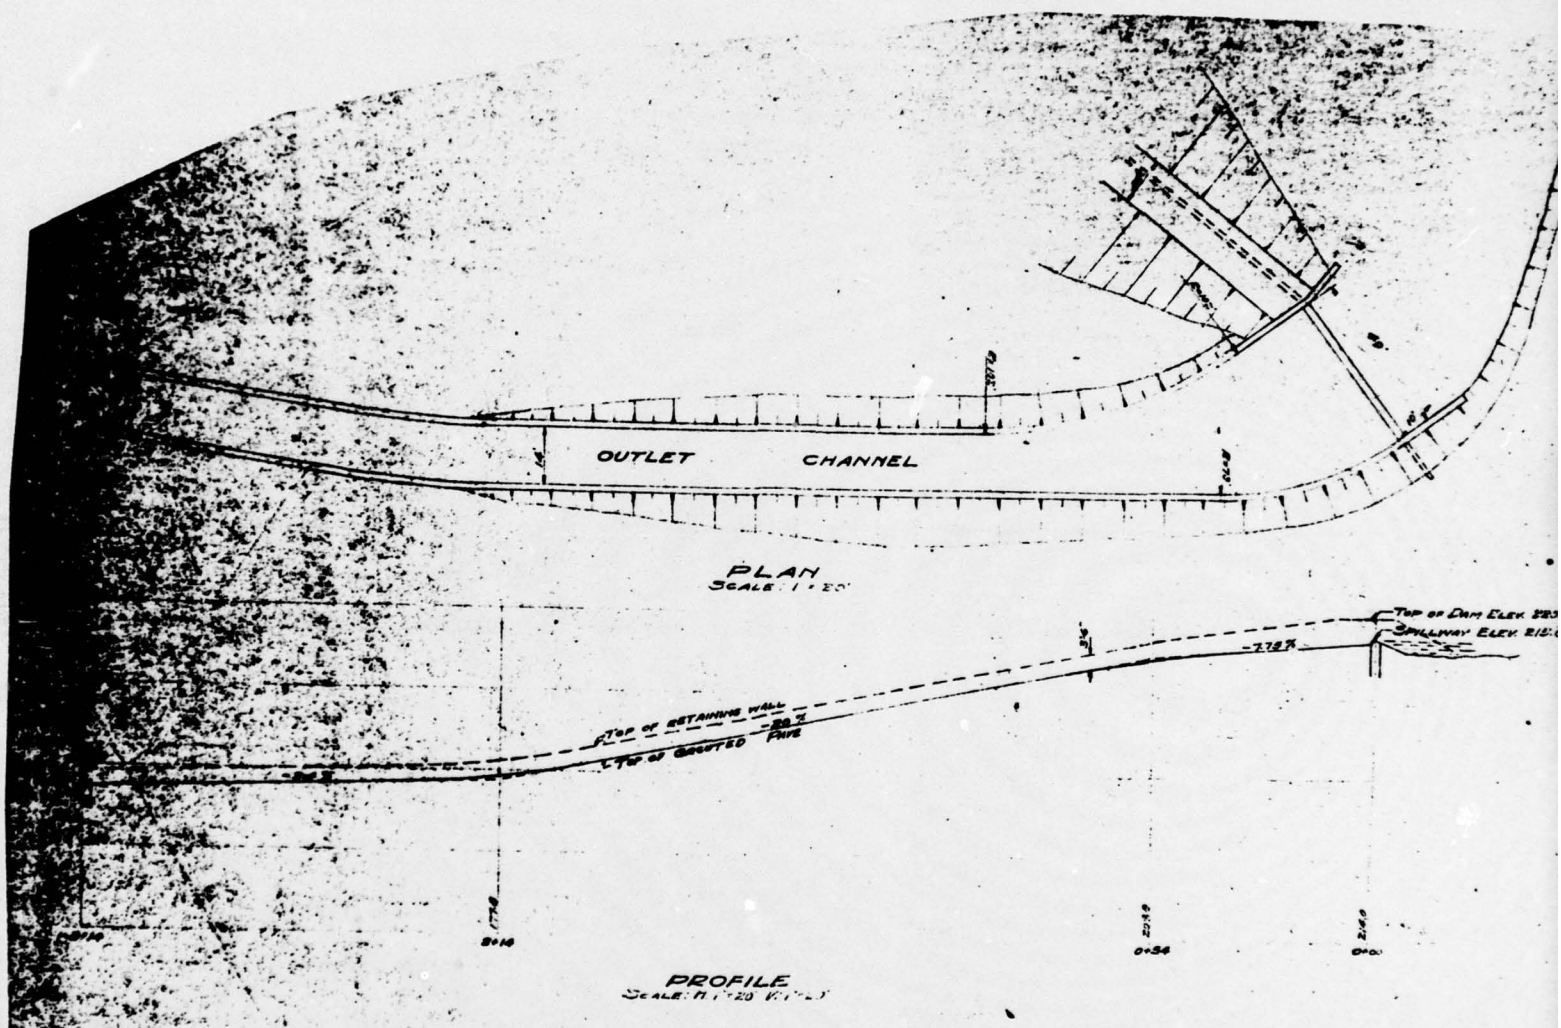
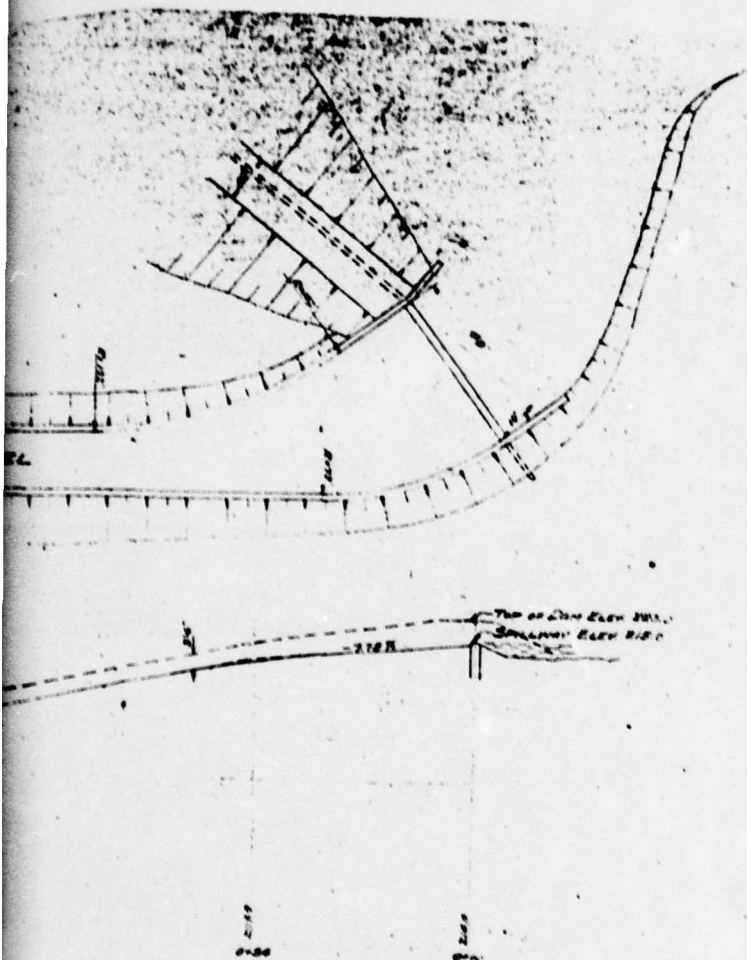
PLATE 4

Shortly after construction, several cracks were noted at the junction of the spillway weir with the retaining walls, which subsequently worsened and, in 1949, these were cited for repairs. Repair work began and was finished in that same year, in which the entire spillway system was rehabilitated. A plan and profile of the spillway are shown in Appendix E as Plate 4.

1. The emergency spillway should be evaluated and rehabilitated in accordance with the findings of a registered professional engineer.
2. Seepage through the embankment should be collected and monitored for changes in flow rates and turbidity.
3. Provisions should be made to periodically inspect the gatehouse tower and the intake and discharge pipes.
4. The depression noted on the crest of the embankment should be inspected annually and filled, if necessary.

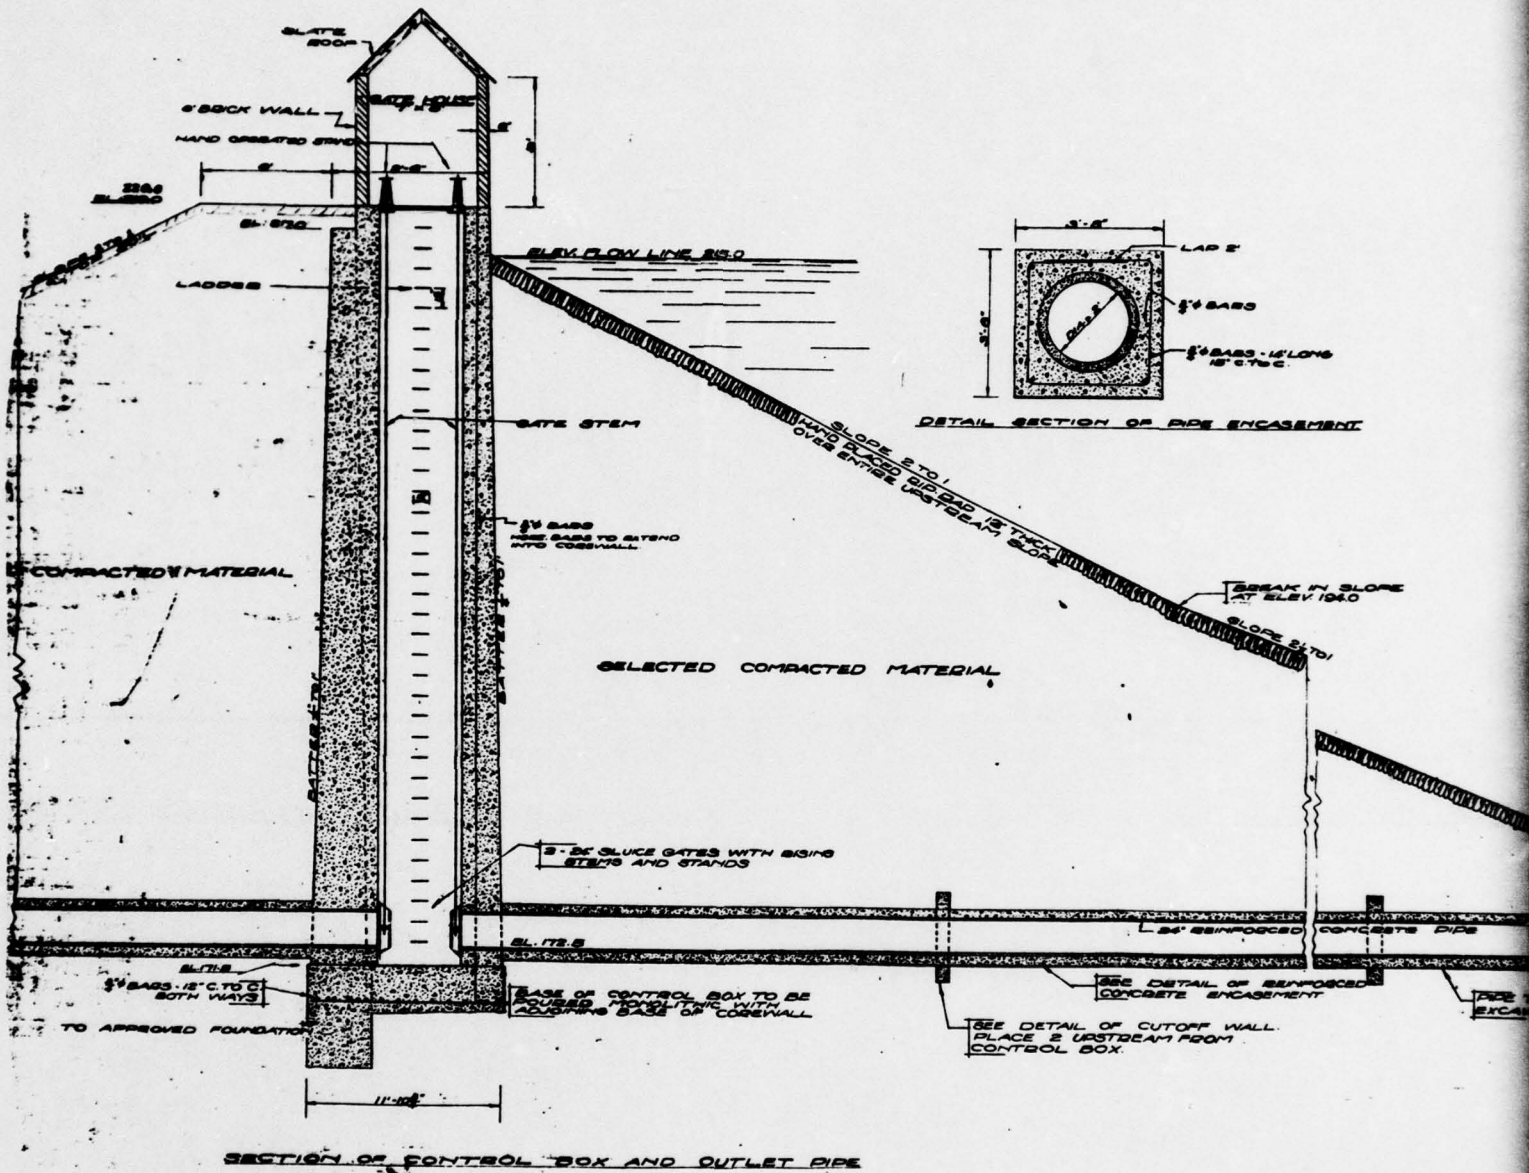
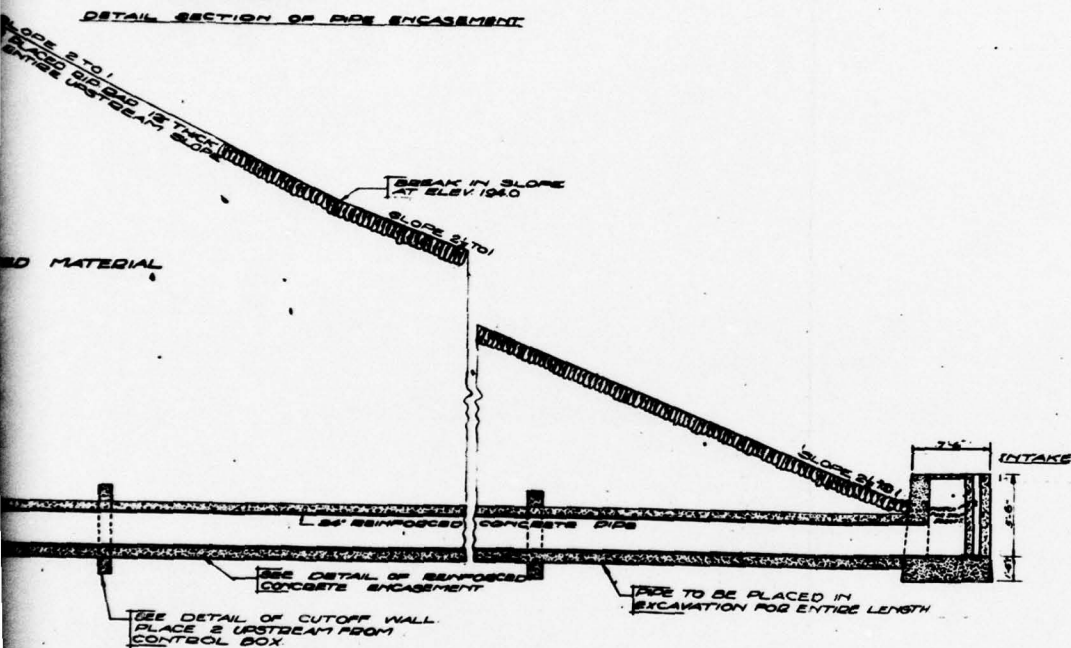
PLATE 5

The gatehouse is located about 320 feet from the right abutment. The best available section of this gatehouse is shown on Plate 5, Appendix E. The sluice gates are inside the gatehouse, one for the 24-inch intake pipe and one for the 24-inch discharge pipe. The intake is located at the upstream toe and the outlet discharges at the downstream toe into a rocklined channel.

NOTE:
REMOVE EXISTING REIN.
CONC. ROOF
UPPER COURSES OF
BRICK TO BE REPAIRED.
USE ADDITIONAL BRICK AS
NECESSARY FOR NEW
ROOF

- WORK INCLUDED IN THIS CONTACT:
1. REPLACE STEMS AND STEM GUIDES
 2. CONNECT NEW STEMS TO EXISTING GATES AND STANDS
 3. REPLACE GRATING AND BEAMS IN GATE HOUSE FLOOR
 4. REPLACE EXISTING GLASS WINDOW PANES WITH LEXAN AND REGLAZE.
 5. REPLACE EXISTING REINFORCED CONCRETE ROOF WITH CORRUGATED GALVANIZED STEEL ROOF WITH JOISTS
 6. REPOINT AND/OR REBUILD UPPER 3 COURSES OF BRICK IN GATE HOUSE
 7. FURNISH AND INSTALL BRONZE PLAQUE
